# SAFETY AND ECONOMIC ASPECTS OF THE WIND ON AVIATION

## Roland Winkler

**Roland Winkler**  
**Safety and Economic Aspects of the Wind on Aviation**

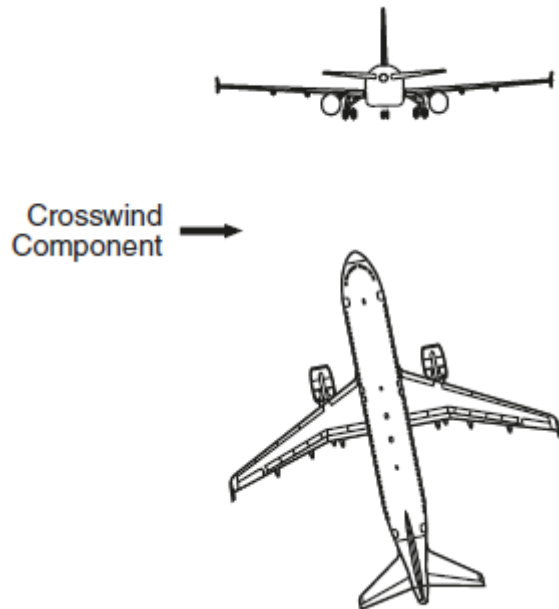
**Crabbed Approach**

- wind with a component directed perpendicular to heading of an aircraft
- critical to air navigation – biggest impact during takeoff and landing
- landing into the wind
  - ✓ minimized groundspeed
  - ✓ shorter runway required to achieve lift-off
  - ✓ pilots have more time making adjustments for smooth landing
- crosswind – aircraft directional control is affected
  - ✓ aircraft may drift off the side of the runway
  - ✓ sideload on landing gear may occur

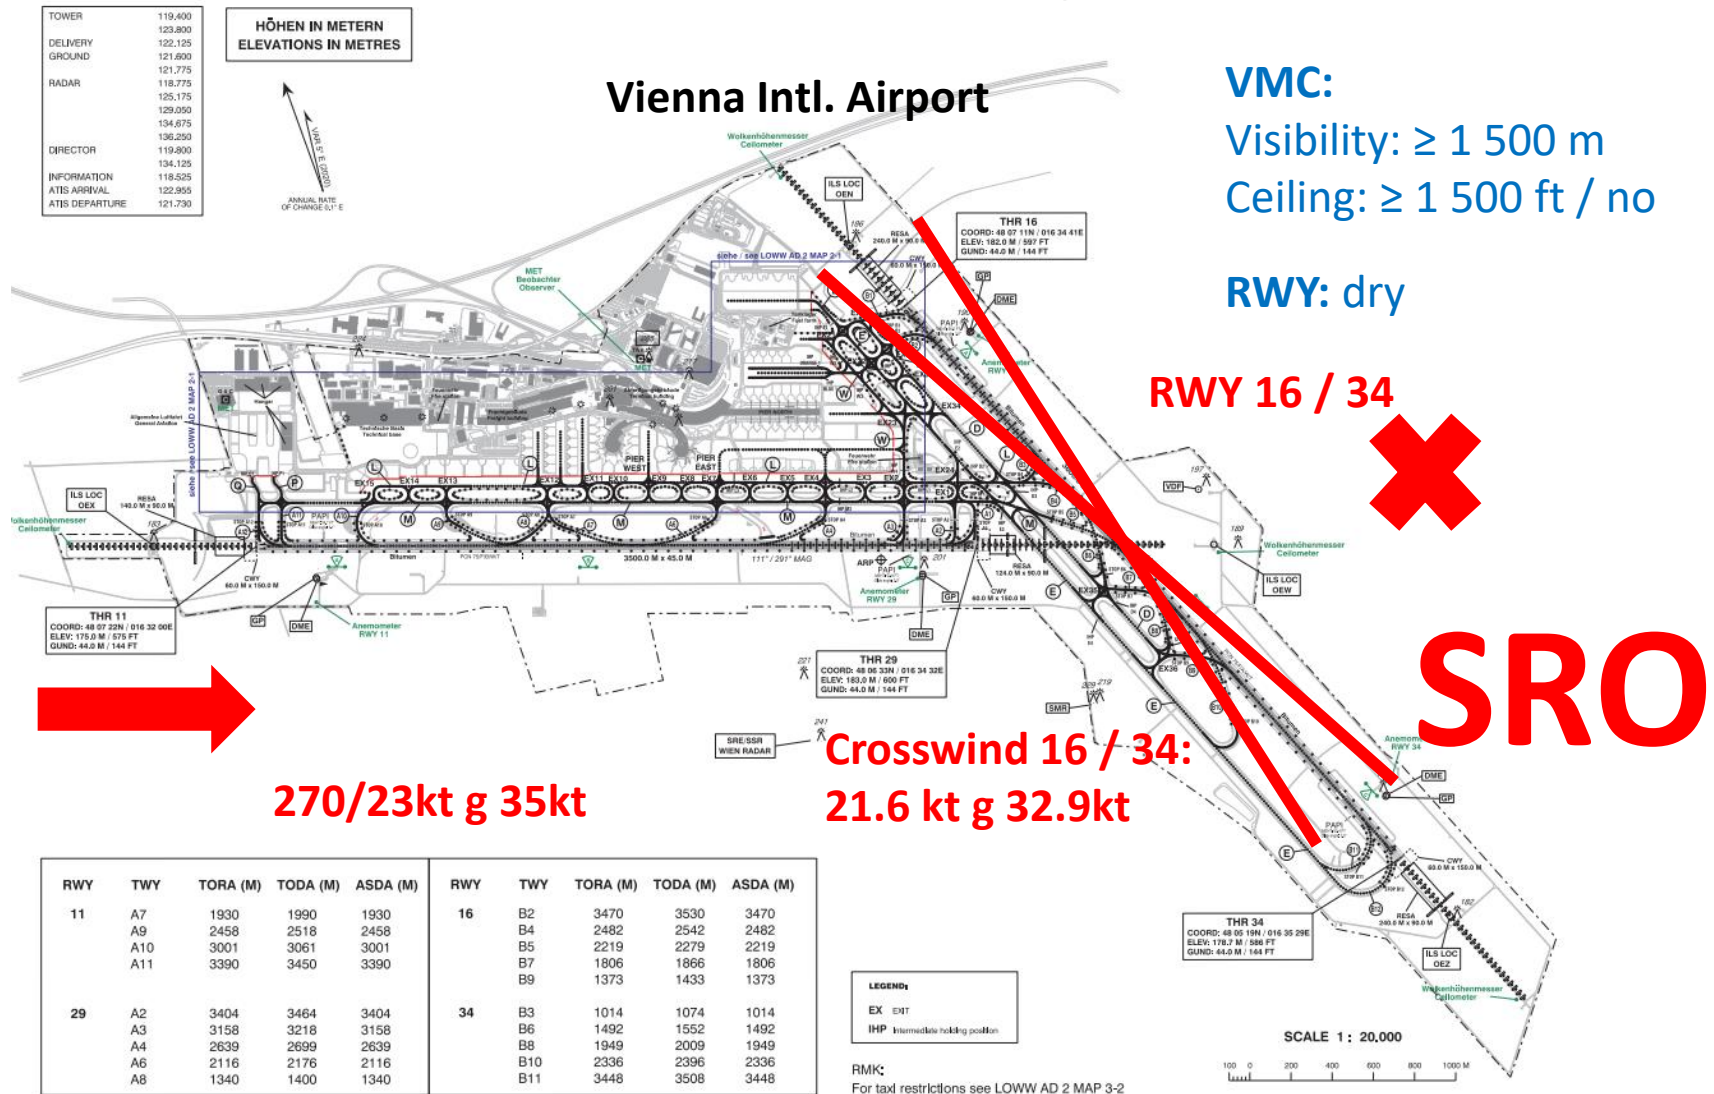
# Crosswind – Case Study LOWW (2)

**Crosswind 16 / 34:**  
**17.6 kt g 26.8kt**

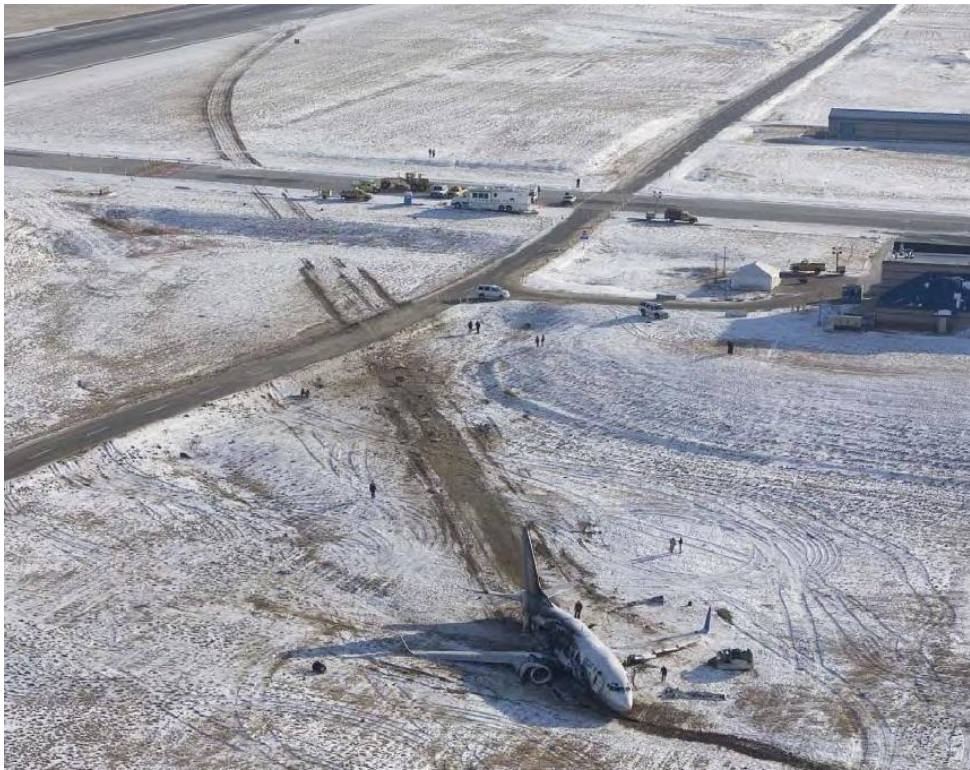
- December 20, 2008
- Denver Int. Airport, RWY 34R
- take off – veered off the side of the runway
- speed plane: 87 – 90 kt
- reported wind: 24 – 27 kt, gusts nearly 32 kt
- crosswind limitation for 737: 33 kt (dry runway)
- 40 kt crosswind at end of the runway

**Aircraft was hit with a peak gust crosswind of 45 kt.**

Credit: Wikipedia – Continental Airlines Flight 1404; Original: NTSB – <https://aviation-safety.net/photos/displayphoto.php?id=20081220-0&vnr=2&kind=C>  
Continental Airlines Flight 1404 wreckage

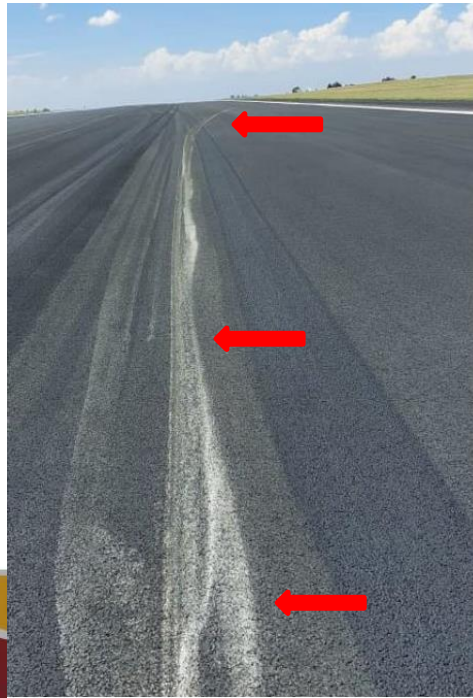
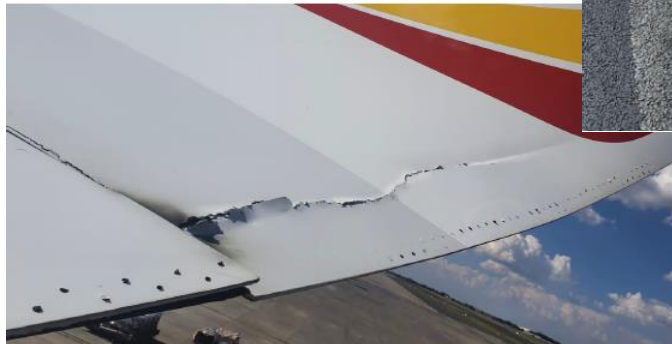
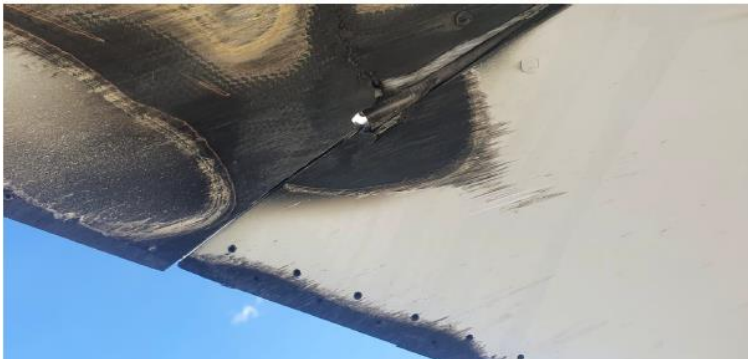
- November 6, 2021
- Tambo Int. Airport, RWY 03L
- FNA: ATC reported 300/22kt
- crosswind landing technique
- pilot attempt to land within touchdown zone
- was not possible
- pilot concluded wind shear
- go-around – during initial stage

**gust from left caused aircraft to  
bank (wing scratches 110 m  
long over the runway)**

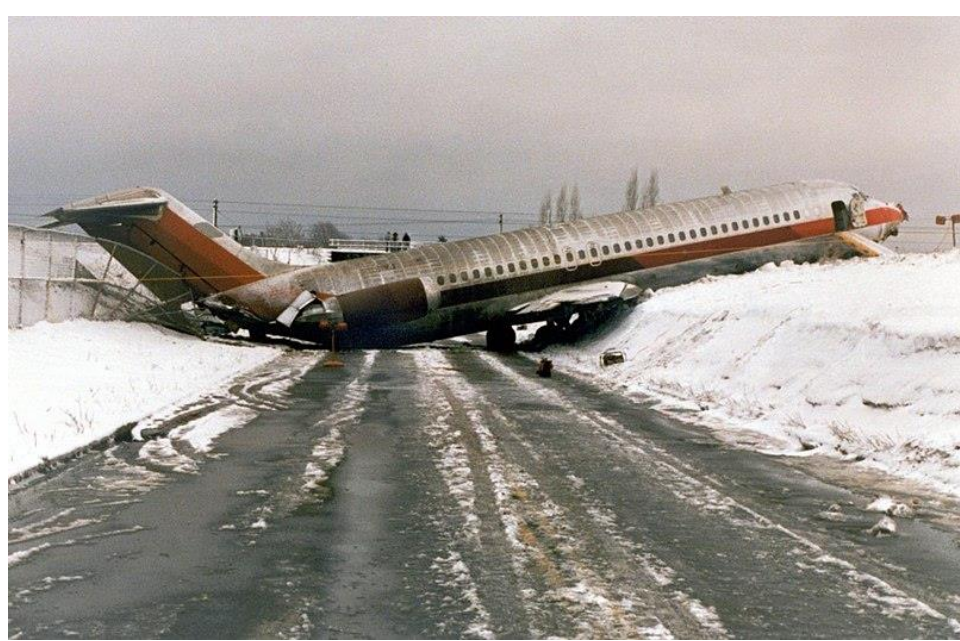
- February 21, 1986
- Erie Int. Airport
- wind: 030/10 kt; wind picked up
- **tailwind: 10 to 11 kt**
- runway covered snow
- breaking action: fair to poor
- touch down some 2 000 ft beyond displaced threshold
- spoilers, reverse thrust, brakes activated

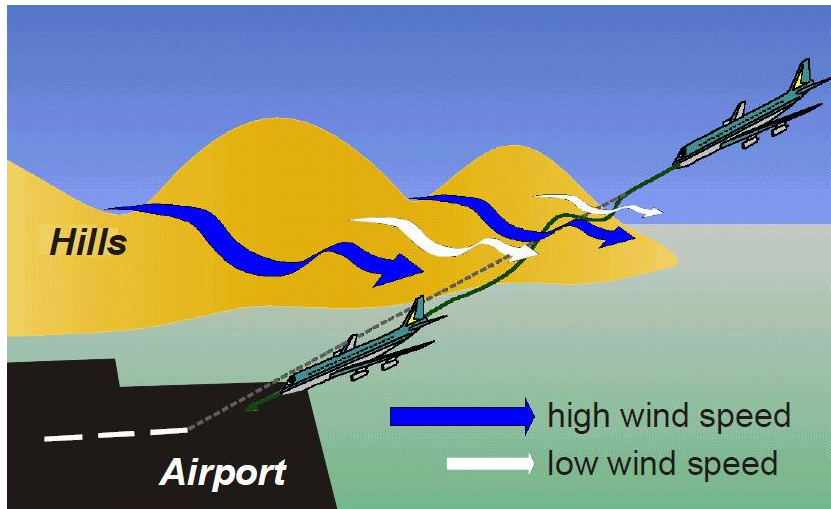
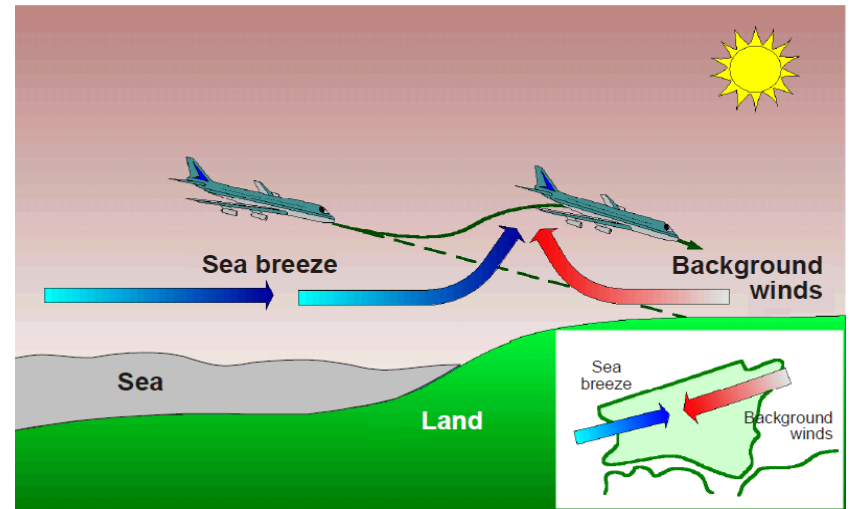
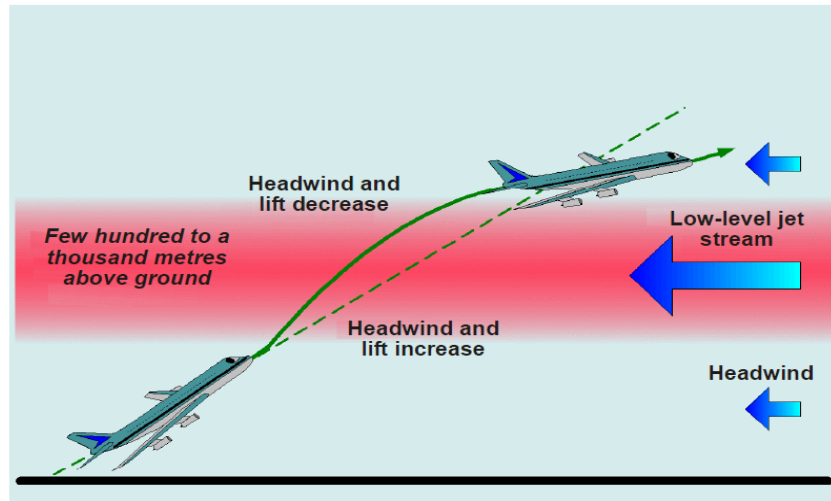
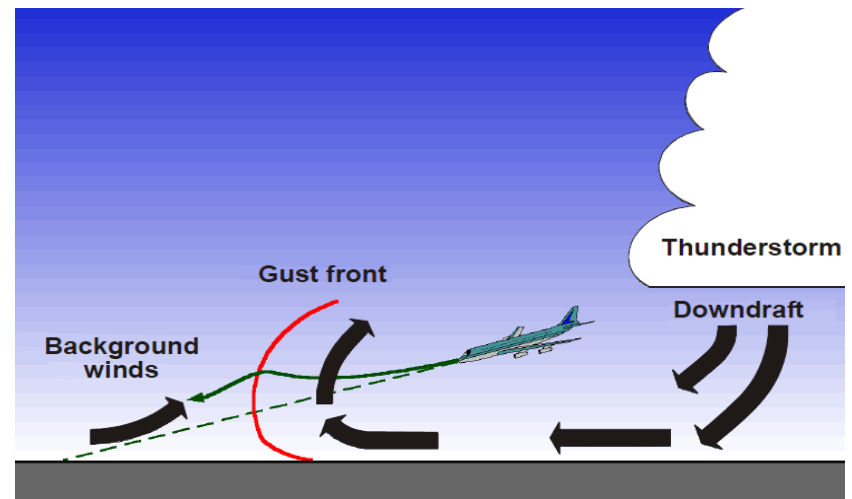
# Wind Shear

Credit: Manual on Low-Level Wind Shear; ICAO Doc 9817 AN/449

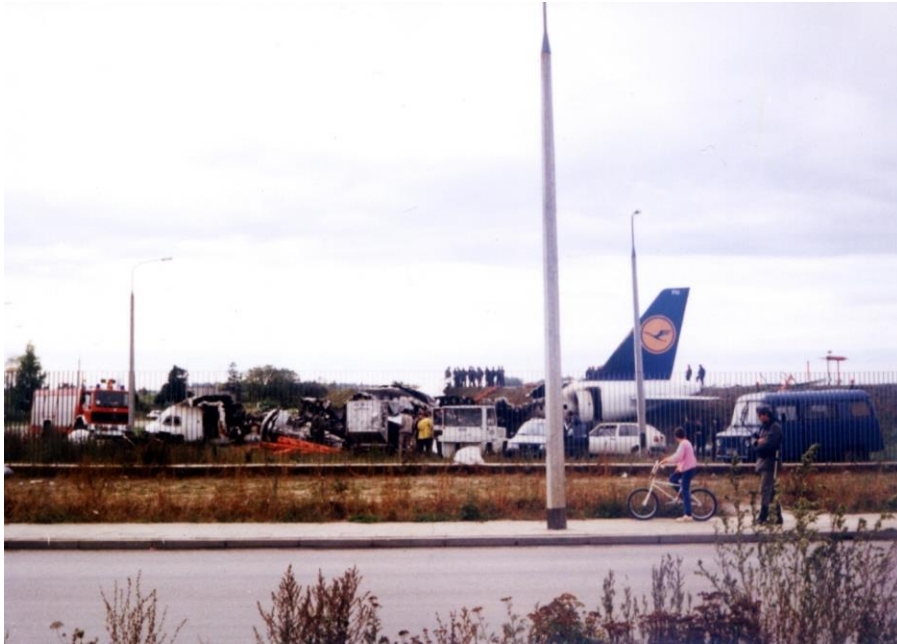
- September 14, 1993
- Warsaw Int. Airport
- wind shear on approach
- ground contact of right main gear after 770 m
- pilot operated wheel brake
- ground contact of left main gear after 1 525 m
- fly-by-wire systems released spoilers and thrust reversers as braking aids after left landing gear came into contact with the ground

change of software - the landing gear's touchdown pressure for releasing spoilers and reversing thrust has been reduced from 12 to 2 t for A320 family
